# DTE Energy Monroe Power Plant

## **Bottom Ash Impoundment CCR Rule Compliance Project**

### **Annual Inspection Report - 2024**

Project Number: 60733958

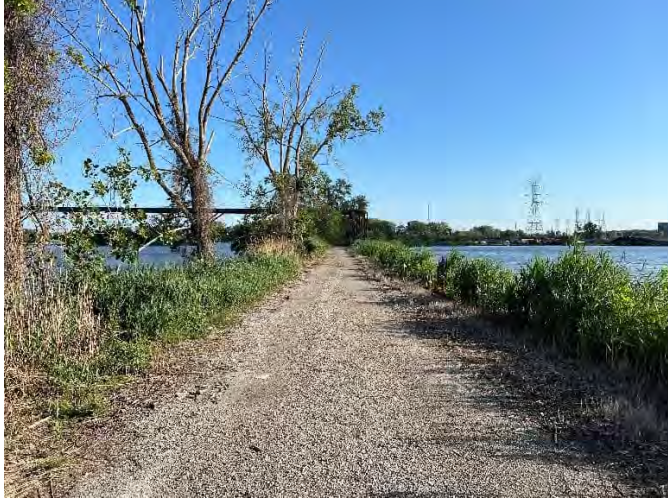
29. Is there natural hillside seepage in embankment area?				<input type="checkbox"/> Yes <input checked="" type="checkbox"/> No <input type="checkbox"/> NA
	Describe seepage with regard to quantity and clarity (turbidity). Note changes: N/A				
	Comments /Action Items West – tall/woody vegetation should be removed, however is not a significant concern due to fair overall condition of embankment and small water level differential. Unable to observe signs of erosion, animal burrows, etc. South – some vegetation growth but in good condition. East and North – vegetation along slope of adjacent process water ditch in fair condition, no signs of erosion observed.				
Actions <input type="checkbox"/> None <input checked="" type="checkbox"/> Maintenance <input type="checkbox"/> Monitoring <input type="checkbox"/> Minor Repair <input type="checkbox"/> Engineering

**Photo 1: Western perimeter dike, looking north. Gravel road in satisfactory condition. Heavy vegetation visible on both slopes, with large/woody vegetation on downstream/west slope.**

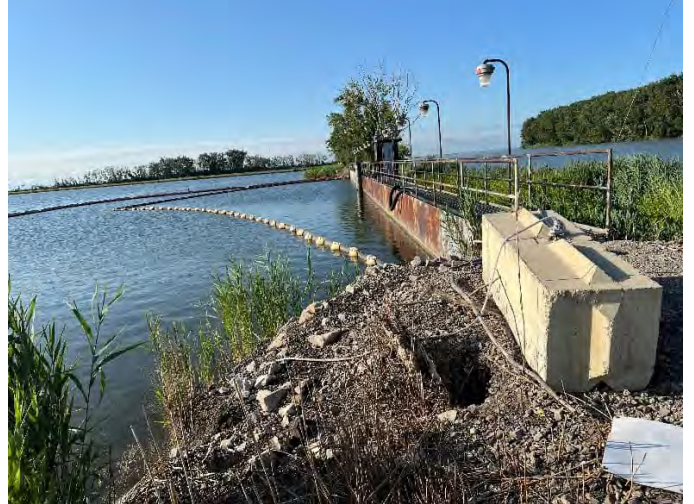
Comments /Action Items West – tall vegetation needs maintenance in some areas. Small sinkholes (see photo 2) observed just north of weir spillway should be filled with gravel and monitored. Minor ruts/depressions in some areas should be filled/leveled as part of regular roadway maintenance. South – separation berm roadway along crest in fair condition, however is at risk due to erosion noted along slope. DTE has closed road to vehicular traffic until such time repairs can be completed. East and North – riprap recently placed along majority of crest as part of closure activities. Small section along northwest slope scheduled for completion later this year.				
	Actions <input type="checkbox"/> None <input checked="" type="checkbox"/> Maintenance <input checked="" type="checkbox"/> Monitoring <input checked="" type="checkbox"/> Minor Repair <input type="checkbox"/> Engineering				
<b>DOWNSTREAM SLOPE/FACE</b>	<b>PROBLEMS</b>				<b>COVER:</b>

**Photo 2: View of upstream side of principal spillway structure from north. Small sinkhole visible in foreground. A few similar sinkholes behind concrete bin block, not visible.**

- The downslope sides of portions of the Impoundment (especially the western side) are heavily vegetated and/or below the water surface. A thorough inspection of the entire surface perimeter of the impoundment is not practical. Maintenance of the vegetation is advised.
- A few small sinkholes (between several inches up to a foot in diameter and depth) were observed in the dike immediately north of the principal spillway. It is recommended to fill these with gravel and continue to monitor and maintain.

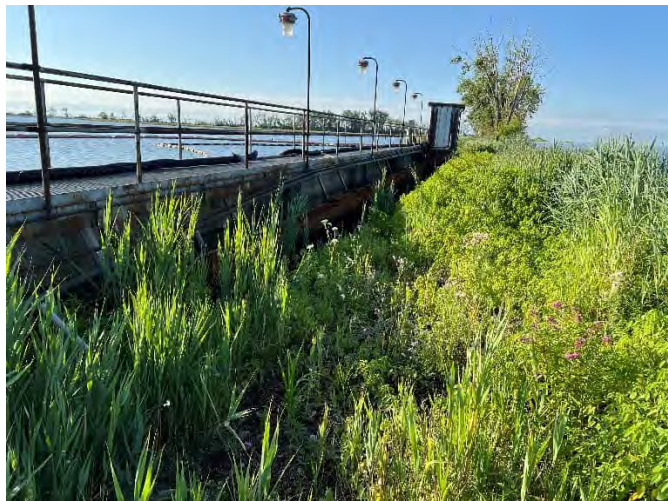
Comments /Action Items 207.5 foot long steel weir observed to be inactive (water level below weir) with minor corrosion and some leakage at vertical joints between steel weir plates, but otherwise in good condition. Downstream outlet channel obstructed with overgrown vegetation which should be removed/maintained to allow for better future inspection and to allow for clear flow path when spillway activates. Some riprap observed immediately downstream of weir.					
Actions <input type="checkbox"/> None <input checked="" type="checkbox"/> Maintenance <input type="checkbox"/> Monitoring <input checked="" type="checkbox"/> Minor Repair <input type="checkbox"/> Engineering					
<b>EMERGENCY SPILLWAY</b>	<b>OBSERVATIONS</b>				
	<input type="checkbox"/> No emergency spillway			<input checked="" type="checkbox"/> Same as principal spillway	
	<b>PROBLEMS</b>				<b>CHANNEL LINING</b>
	<input type="checkbox"/> 1. None <input type="checkbox"/> 2. Debris in channel <input type="checkbox"/> 3. Gates <input type="checkbox"/> 4. Misalignment	<input type="checkbox"/> 5. Joint deterioration <input type="checkbox"/> 6. Joint displacement <input type="checkbox"/> 7. Exposed reinforcement <input type="checkbox"/> 8. Erosion	<input type="checkbox"/> 9. Undermining <input type="checkbox"/> 10. Voids <input type="checkbox"/> 11. Cracks <input type="checkbox"/> 12. Holes <input type="checkbox"/> 13. Outlet erosion	<input type="checkbox"/> 14. Displaced rip rap <input type="checkbox"/> 15. Sparse rip rap <input type="checkbox"/> 16. Outlet undercutting <input type="checkbox"/> 17. Inadequate capacity <input type="checkbox"/> 18. Other	<input type="checkbox"/> Vegetation <input type="checkbox"/> Rip rap <input type="checkbox"/> Concrete <input type="checkbox"/> Asphalt <input type="checkbox"/> Other

**Photo 3: View of downstream side of principal spillway structure from north. Riprap outlet channel overgrown with vegetation.**

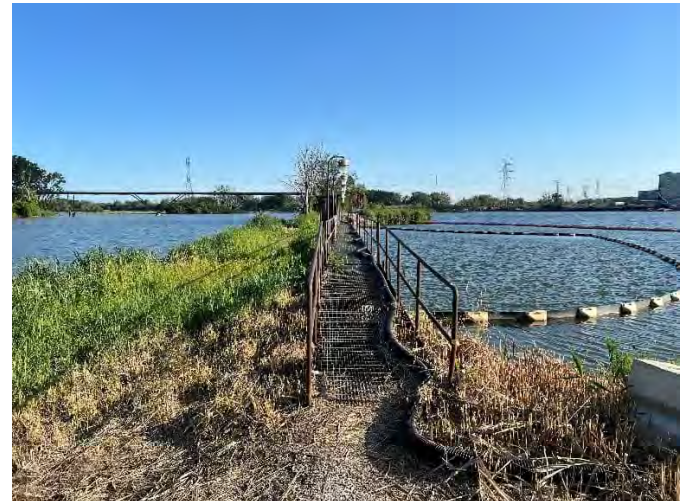
12. other	<input type="checkbox"/> Yes <input type="checkbox"/> No <input checked="" type="checkbox"/> N/A
<p>Comments /Action Items</p> <p>Walkway/structure observed to be in satisfactory condition with minor wear and tear and corrosion. Spillway not active, so no turbidity impacts to observe, however noted turbidity curtains on impoundment/inlet side to be in good condition.</p>		
<p>Actions <input checked="" type="checkbox"/>None <input type="checkbox"/>Maintenance <input type="checkbox"/>Monitoring <input type="checkbox"/>Minor Repair <input type="checkbox"/>Engineering</p>		
RESERVIOR/POOL	OBSERVATION	
	Has there been a sudden drop in the level of the Impoundment <span style="float: right;"><input type="checkbox"/> Yes <input checked="" type="checkbox"/> No</span>	
	PROBLEMS	
	<input checked="" type="checkbox"/> 1. None <input type="checkbox"/> 2. Inadequate freeboard <input type="checkbox"/> 3. Skimmer <input type="checkbox"/> 4. Depressions <input type="checkbox"/> 5. Whirlpools <input type="checkbox"/> 6. Sinkholes <input type="checkbox"/> 7. Unwanted growth in pond water

**Photo 4: View of principal spillway walkway from south.**

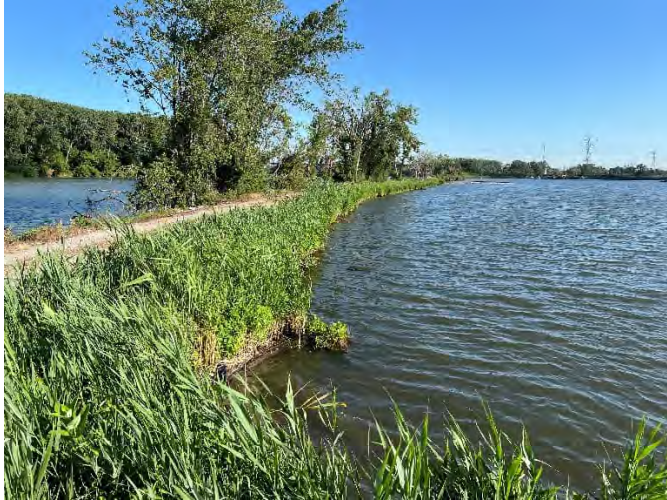
**Photo 5: Impoundment side of western perimeter dike, looking north. Photo taken from separation berm at southwest corner of impoundment.**

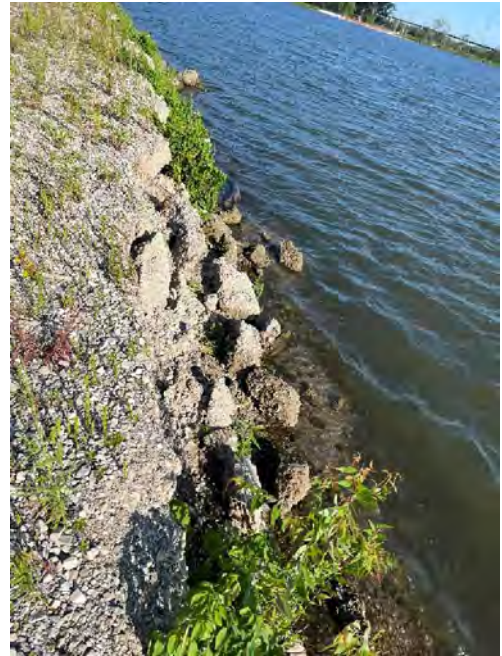
- The northern/upstream face side of the separation berm continues to show signs of erosion and sloughing, as noted in last year's report; this is especially visible on the western portion for a length of approximately 100-150' where plastic bollards have been impacted. This has occurred due to wave action and undercutting from dredging of CCR in these areas. Repair of this upstream section is anticipated to occur either with completion of the closure project or immediately after – the sloughing is not an immediate threat (a width of approximately 20 feet of the separation berm at the crest still exists and DTE has temporarily ceased vehicle traffic over the berm).

Comments /Action Items West – tall vegetation needs maintenance. Unable to observe signs of erosion, animal burrows, etc. South – separation berm actively eroding/sloughing, however DTE is aware of the issue and mitigating the risk. Global slope stability analyses have been recently performed to confirm low risk of berm failure. East and North – riprap recently placed along majority of slopes as part of closure activities. Small section along northwest slope scheduled for completion later this year. Some vegetation growth in riprap along toe.	
	Actions <input type="checkbox"/> None <input checked="" type="checkbox"/> Maintenance <input type="checkbox"/> Monitoring <input checked="" type="checkbox"/> Minor Repair <input type="checkbox"/> Engineering

**Photo 6: Sloughing and erosion of south separation berm (impoundment side).**

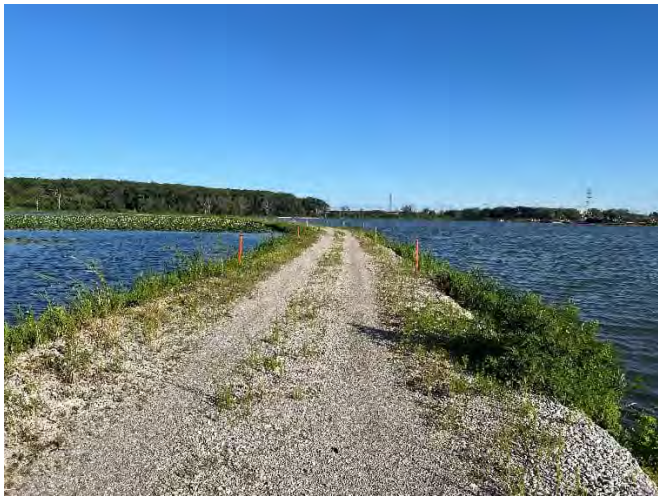
**Photo 7: South separation berm, looking west. Vegetation growth on both sides. Roadway in fair condition, however closed to vehicular traffic due to north (impoundment side) slope sloughing as seen in photo 6.**

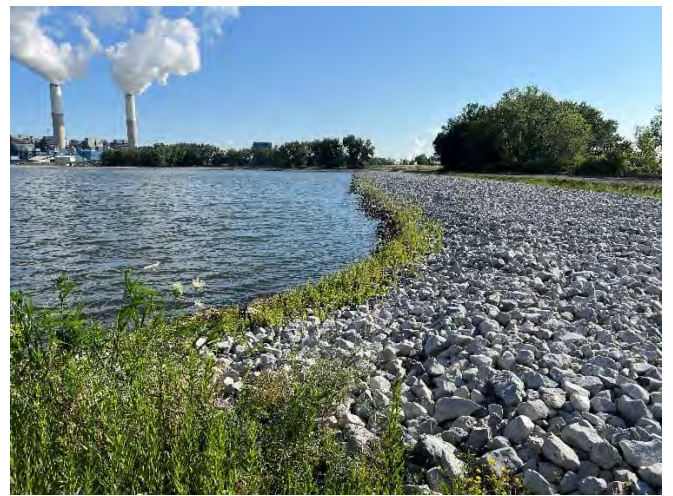
**Photo 8: East internal slope of impoundment, view from south separation berm at southeast corner of impoundment. Riprap cover, typical of east and north slopes. Some vegetation growth near water line.**
